Project Management Deficiencies in Constructing the Paul S. Sarbanes Silver Spring Transit Center

2014 Federal Audit Executive Council Annual Conference

Why Montgomery County Office of the Inspector General Did This Inspection

Our objective: Identify and document any project management deficiencies during the construction of the Silver Spring Transit Center.

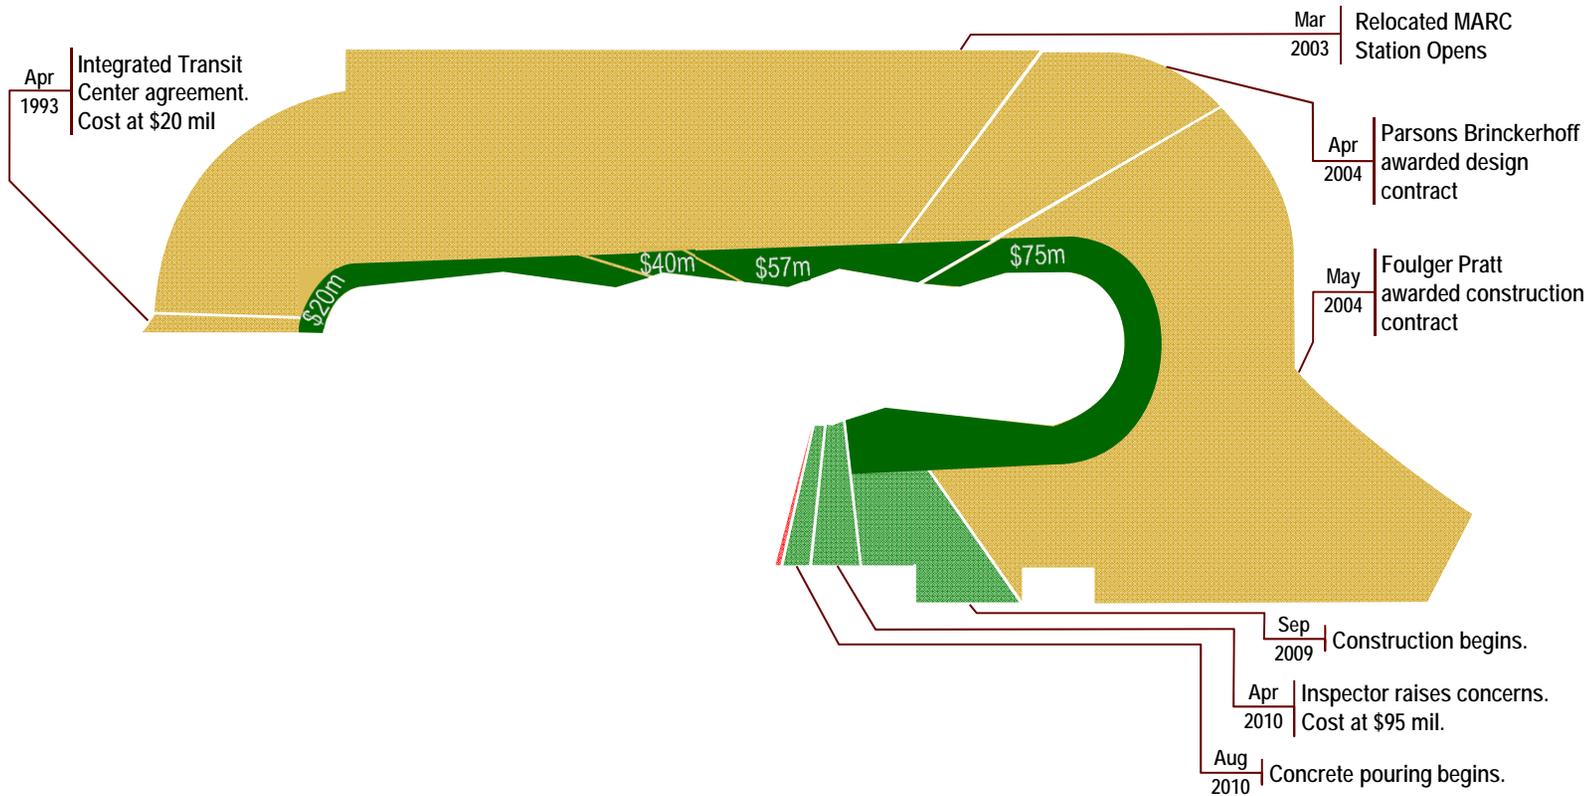
Timeline: September, 2010: Cracking first observed and workers report concrete is too thin in some areas of the center.

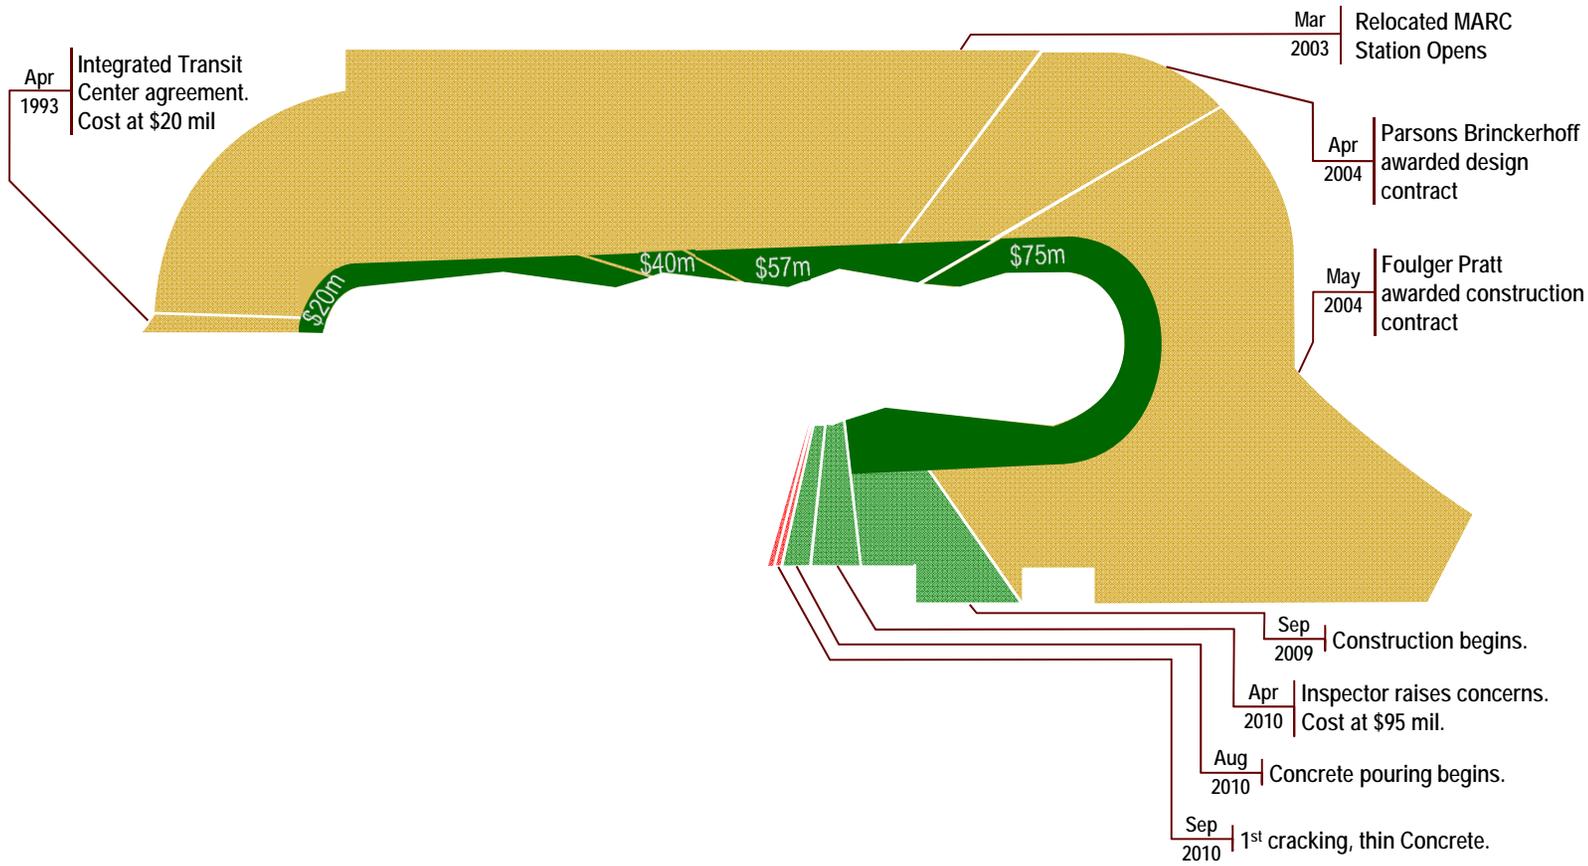
Timeline: October, 2010: Cracking observed in concrete slabs in some areas before post-tension commences. Spalling observed.

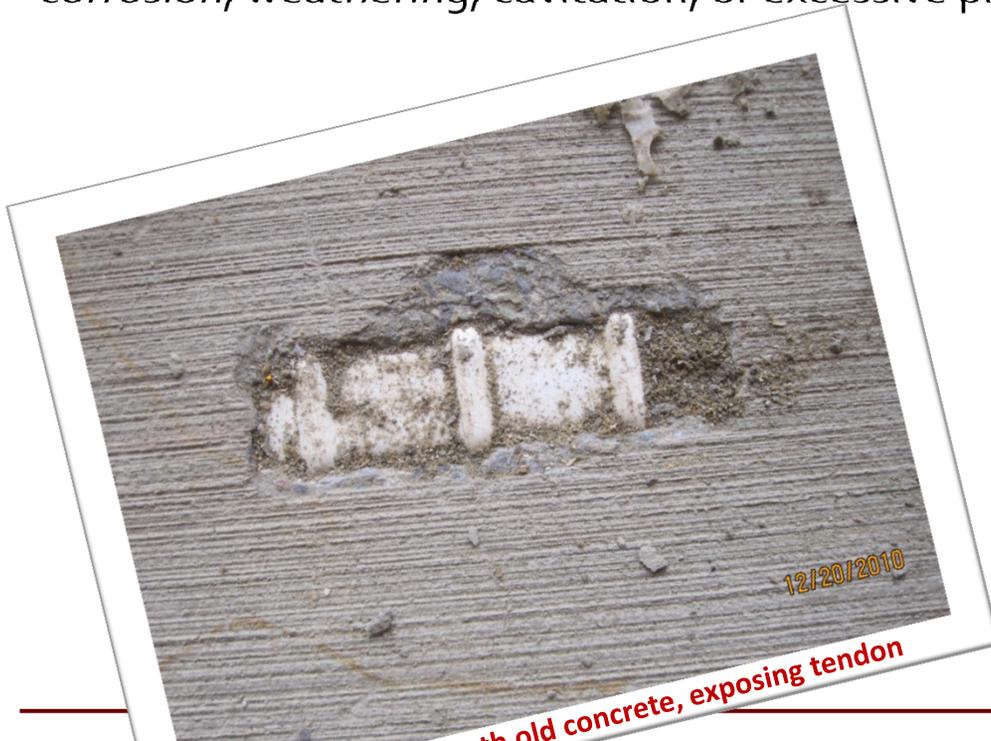
Construction 101: Terminology - Spalling

Spalling is the process of surface failure in which flakes of a material (spall) are broken off a larger solid body and shed. Spalling is usually caused by corrosion, weathering, cavitation, or excessive pressure.

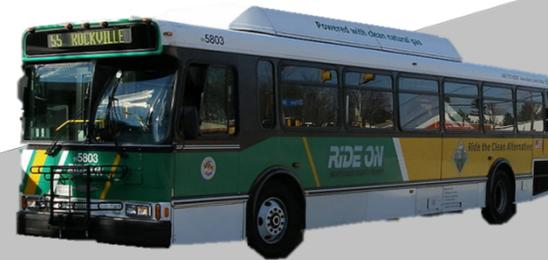
When a spanned concrete surface is presented with a load to bear

- The surface will bow in deference to the load
- However, when post-tension tendons are embedded within the concrete span
- And the tendons are stressed within three days of pouring the concrete
- The surface will convex
- Allowing it to counteract the load

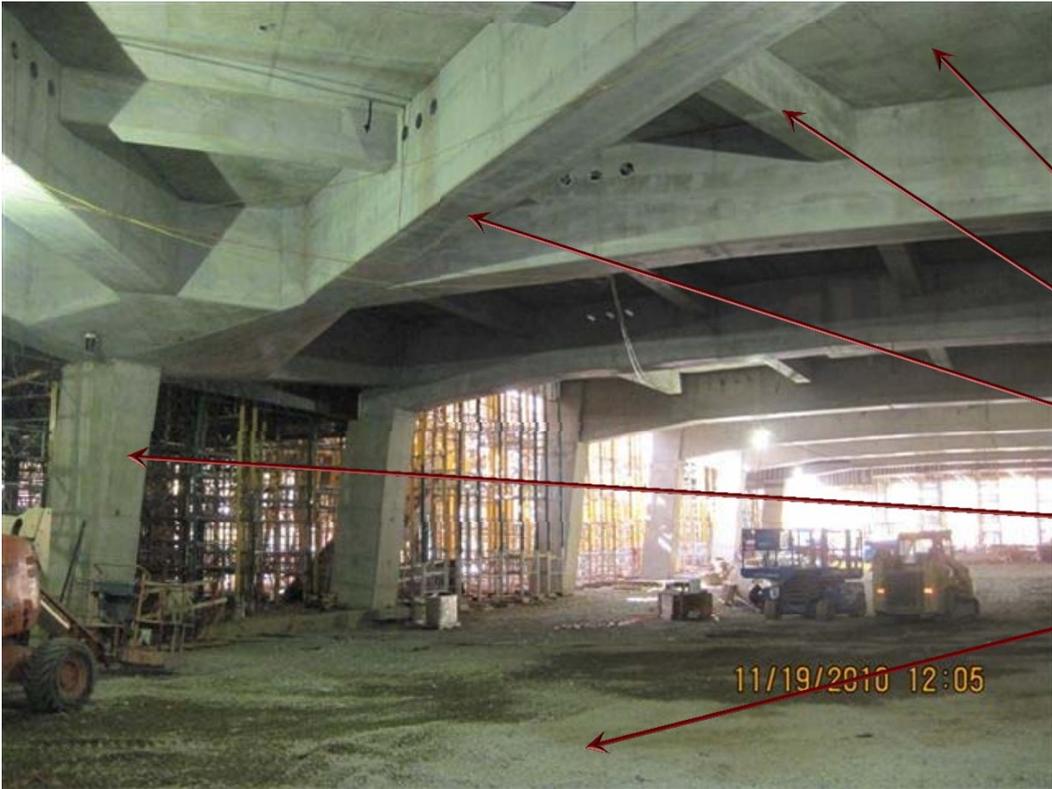
Underside of 3rd Floor
(Level 350)

- Slab (deck) - Underside
- Beam
- Girder
- Column
- Slab (deck) - Topside

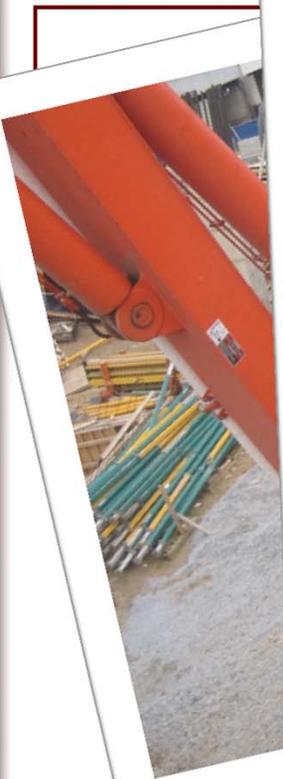
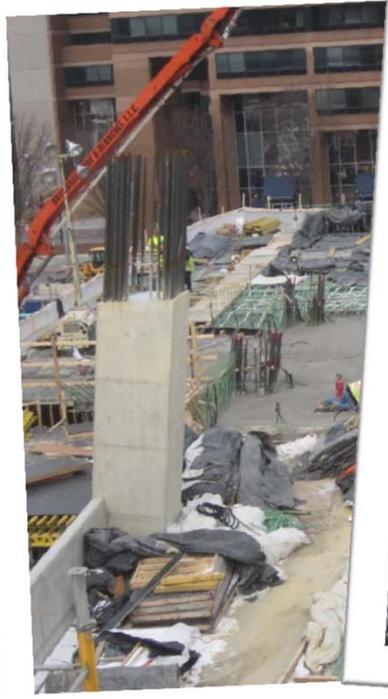
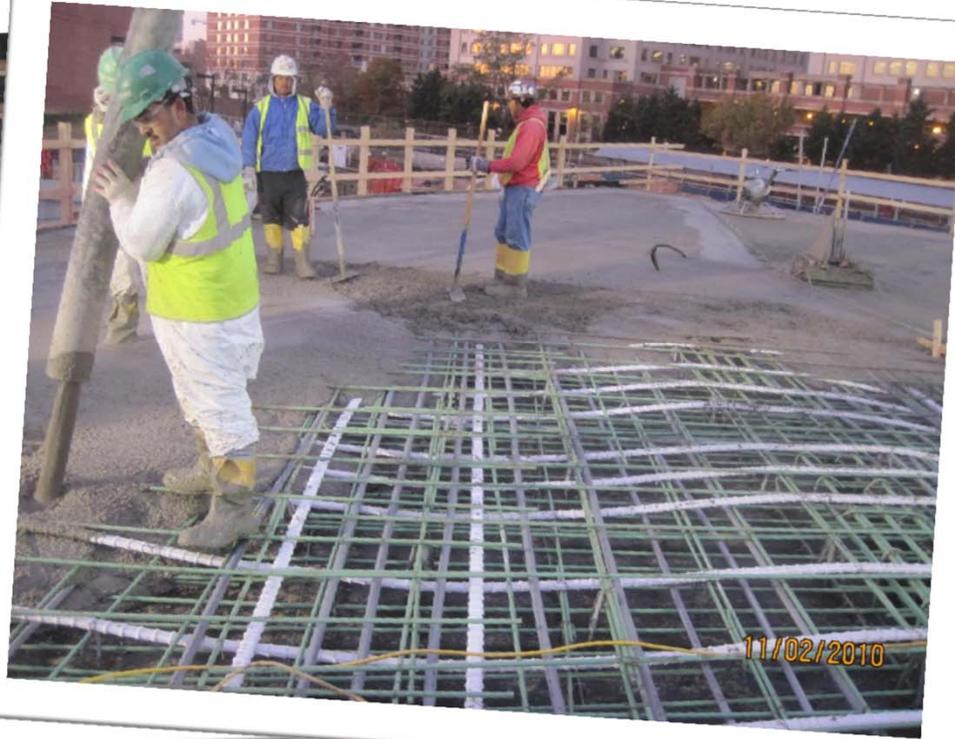
- 6. Pour the concrete
- 7. and allow the
- 8. Remove the form
- 9. and stress the
- 10. and hope the
- 11. Oops!

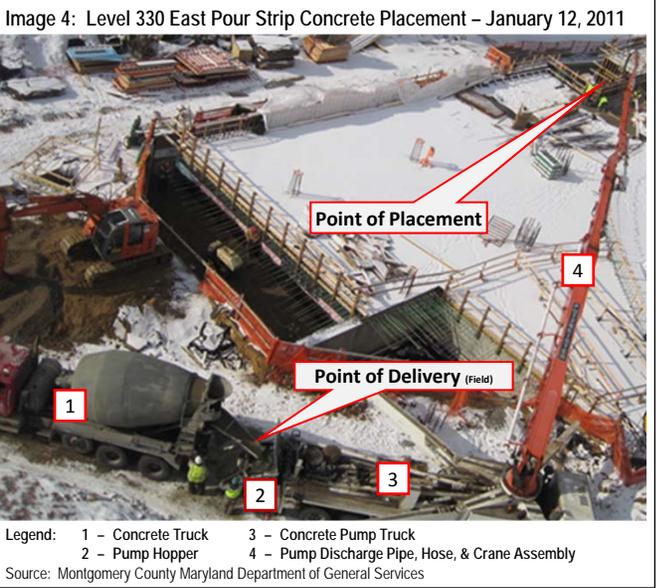
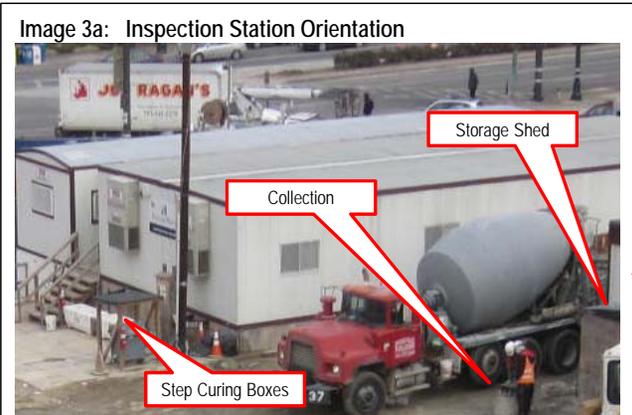
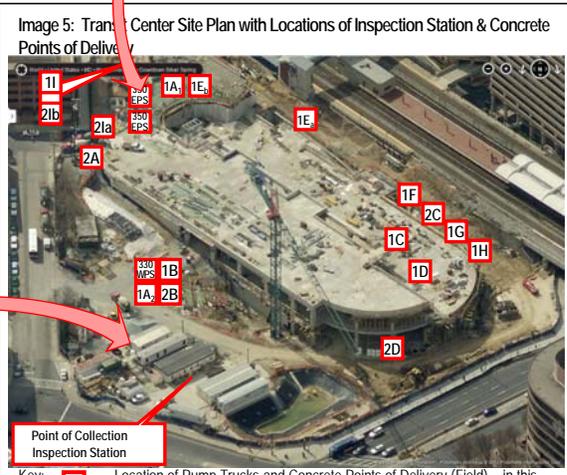
View: Location of Dump Trucks and Concrete Points of Delivery (Field) in this

- Specimen testing samples should have been collected at point of placement
- Consistently weaker than anticipated test results should have led to discovery / correction of concrete mixture issues at early stage
- Weak concrete in structure could have been avoided
- Stronger overall structure
- Would have diminished impact of stress cracks due to tensioning of premature concrete

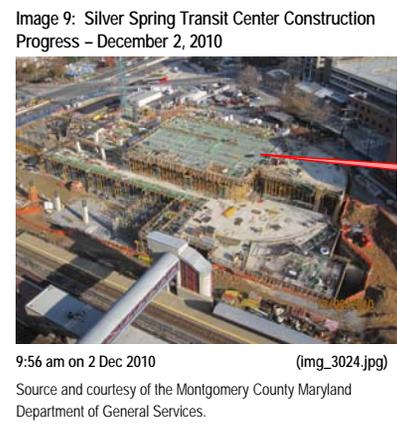
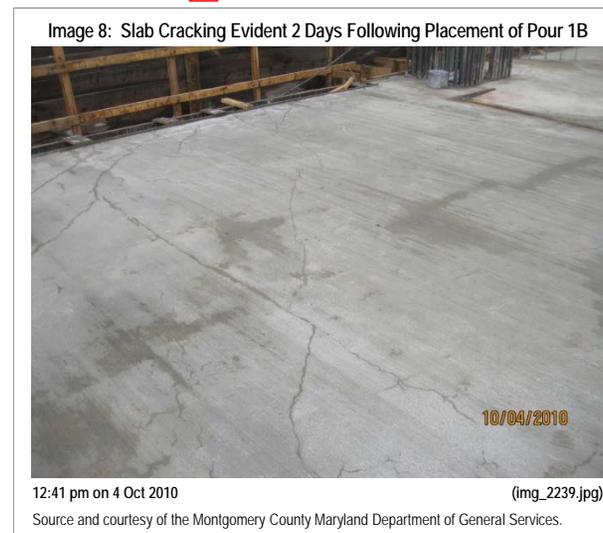
Data Documenting Deficiencies Existed – Was Not Analyzed

- **Routine construction records documented construction & control deficiencies**
- **Available to all stakeholders**
- **Evidenced deficiencies that should have been investigated as to cause(s)**
- **Though not a requirement, available data, if analyzed, would have identified deficiencies**
- **Known deficiencies were not effectively corrected**

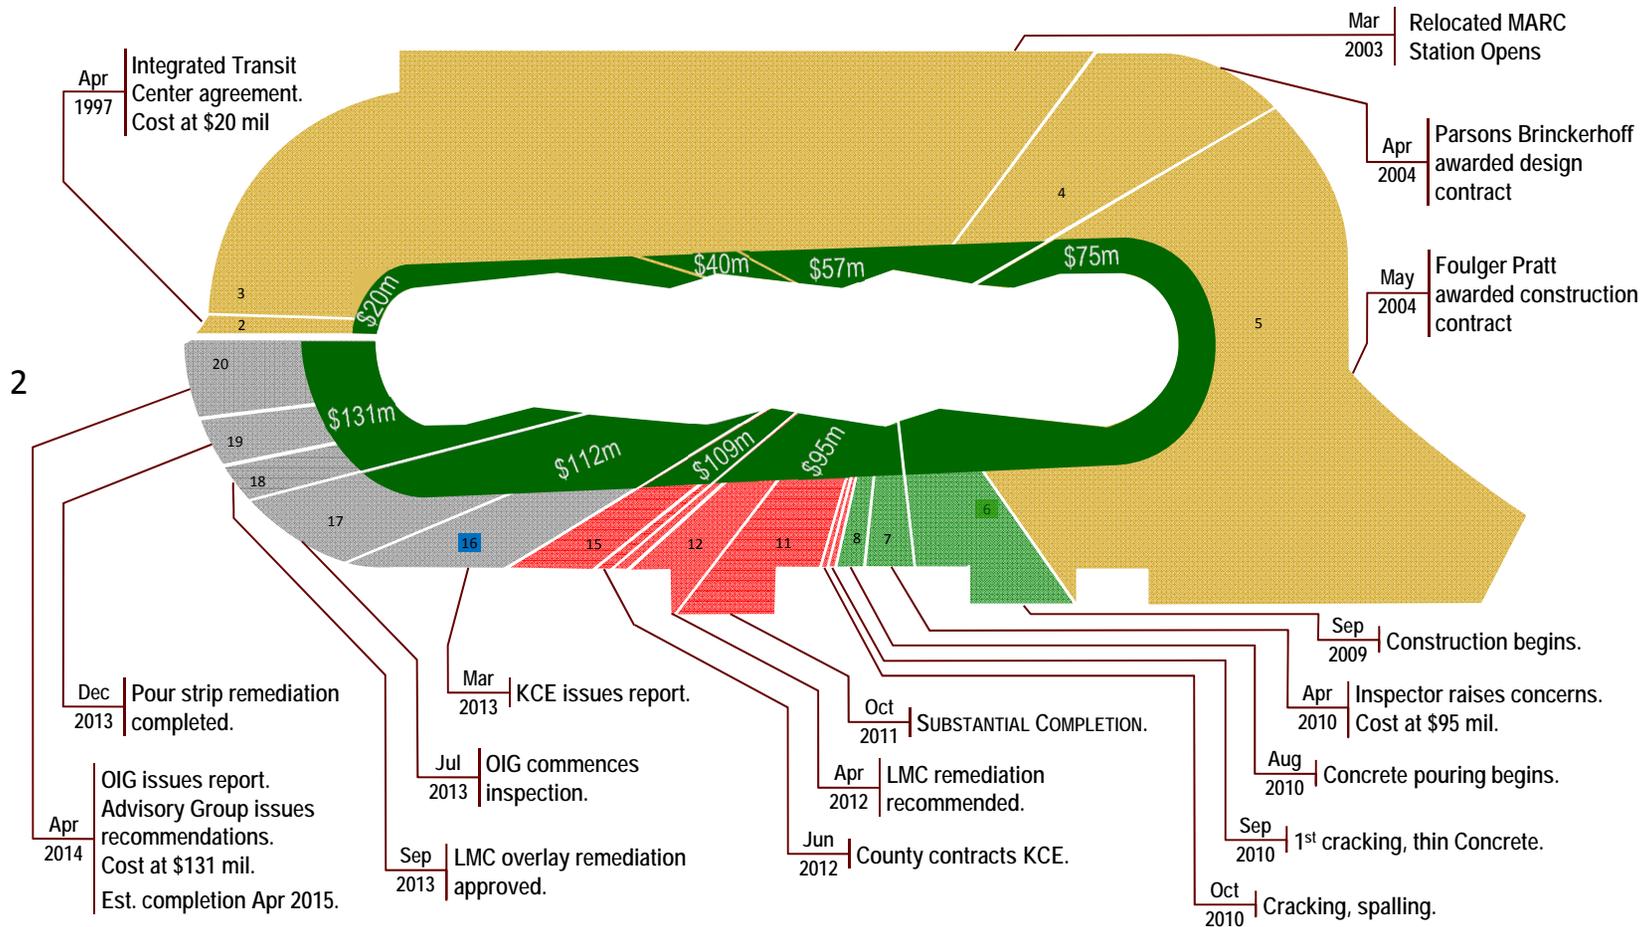
Timeline: April, 2010:

Montgomery County Department of Permitting Services inspector raises concerns that post tensioning of the slabs and girders with the built in wall would create a zone of cracking in the slabs along certain points. Project budget increases to \$95 million.
